October 1, 2018

Subject: **URGENT MEDICAL DEVICE FIELD SAFETY NOTICE – REMOVAL**

Reference: **ZFA2018-00369 & ZFA2018-00374**

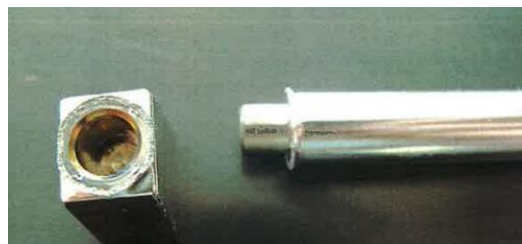
As a precautionary measure Biomet France SARL is conducting a medical device Field Safety Corrective Action (removal) for one specific part of the Avantage Acetabular Shell Inserter. This specific removal deals with the Avantage Thread Shaft Straight part with reference 110027769 (see picture 1 for the instrument configuration) and for the batch numbers as listed above. The removal is due to a potential dissociation of the welded part (see picture 2). No adverse events have been reported to date for this issue.

Picture 2: View of the issue with the straight shaft

Risks		
Describe immediate health consequences (injuries or illness) that may result from use of or exposure to the device issue.	Most Probable	Highest Severity
	Extension of surgical time less than 30 minutes to get alternative instrument.	Extension of surgical time more than 30 minutes in order to retrieve the block in the patient.
Describe long range health consequences (injuries or illness) that may result from use of or exposure to the device issue.	Most Probable	Highest Severity
	None	Potential consequences due to prolongation of the anaesthesia time.

1. Review this notification and ensure that affected personnel are aware of the contents.
2. If you have affected parts at your facility, assist your Zimmer Biomet sales representative and quarantine all affected parts. Your Zimmer Biomet sales representative will remove the affected parts from your facility.
3. Complete **Attachment 1 – Certificate of Acknowledgement** and send to fieldaction.emea@zimmerbiomet.com. This form must be returned even if you do not have affected parts at your facility.
4. Retain a copy of the acknowledgement form with your field action records in the event of a compliance audit of your facility’s documentation.
5. If you have further questions or concerns after reviewing this notice, please contact your Zimmer Biomet representative.

Three options can be followed to perform surgery without the referenced instrument parts affected in this FSN, as per surgical technique reference 0023.1-EMEA-en-REV0316 (English version); see Fig 24 & 37/38:

1. Use of the Shell Positioner available in the same kit (ref. 110027772 and 110027771)
2. Use of the assembly usually used for the cemented shell insertion.
3. Use of the legacy instrumentation, if available.
