URGENT - FIELD SAFETY NOTICE**GETINGE VOLISTA StandOP and TRIOP
Field Action MSA-2017-001-IU**

Date:	March 15, 2018
Product Issue:	Potential keypad failure on VOLISTA StandOP and TRIOP Surgical Lights
Affected Product:	All Getinge VOLISTA cupolas of model StandOP and TRIOP made until June 2017 equipped with keypad ARD568801560. The complete list of affected serial numbers for your market are listed in a separate document (Annex 1).
Resolution:	Maquet SAS proposes to replace the keypads ARD568801560 on the devices with keypads of a different design ARD568805501 to make sure all devices present in the market are working effectively and safely
Affected Serial Nos.:	See Annex 1 (consignee list)
Field Correction Notice:	MSA/2017/001/IU
Pages:	3

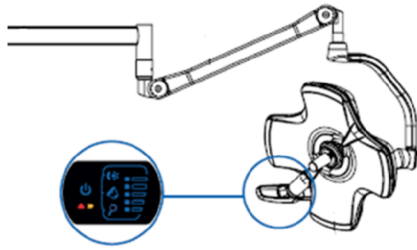
The issue we found can cause a failure of the control keypad. This can result in the cupola not turning on or off. We have received numerous complaints where this problem happened on 3 different keypad versions. From our investigation which includes our evaluation of worst-case scenarios it was concluded that there is only a remote chance that the problem may cause injury. However it is possible.

- 1 On/Off button
- 2 Standard lighting / ambient lighting button
- 3 Light field variation button
- 4 Level display for the selected function
- 5 Button to reduce / increase the selected function level
- 6 Status indicators
- 7 Camera zoom mode setting key

This potential for malfunction is caused by an internal frequency issue of a component on keypads version 1, and by the touch-sensitive technology that was not sensitive enough on versions 2 and 3 . The keypads at fault are no longer produced. We have implemented a more robust keypad using a different technology. Although the probability of occurrence of harm is low, we want to prevent any related event from occurring with our customers.

This action is to replace the potentially defective keypads with the new ones. The devices involved at your facility are listed in the consignee list file you received for this field action.
