#### **URGENT - FIELD SAFETY NOTICE**

#### **ARJOHUNTLEIGH SARA COMBILIZER**

Product Issue: Sara Combilizer tipping hazard

Field Correction Notice: FSN/POZ/002-2016

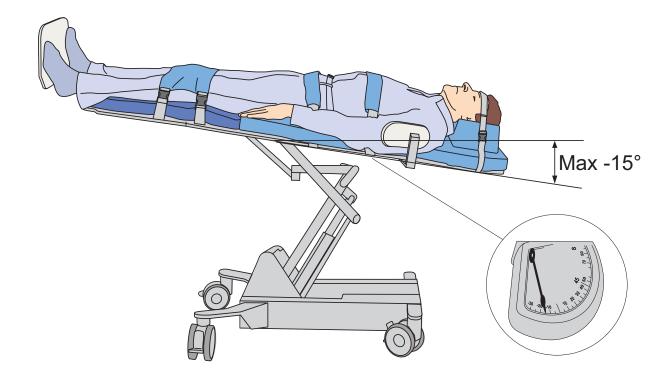
To avoid risk of injury do not place Sara Combilizer with patient in head down tilt greater than -15°.

Degree of tilt can be assessed on the tilt angle indicator located under the head section of the Sara Combilizer.
