**URGENT: FIELD SAFETY NOTICE – VT-RAP-19-02-001 (Rev02)**

EnCor® Breast Biopsy Probe  
Impacted Product Codes/Lot Numbers - Refer to Table 1, Page 3  
Type of Field Action: Advisory  
**UPDATED INFORMATION**

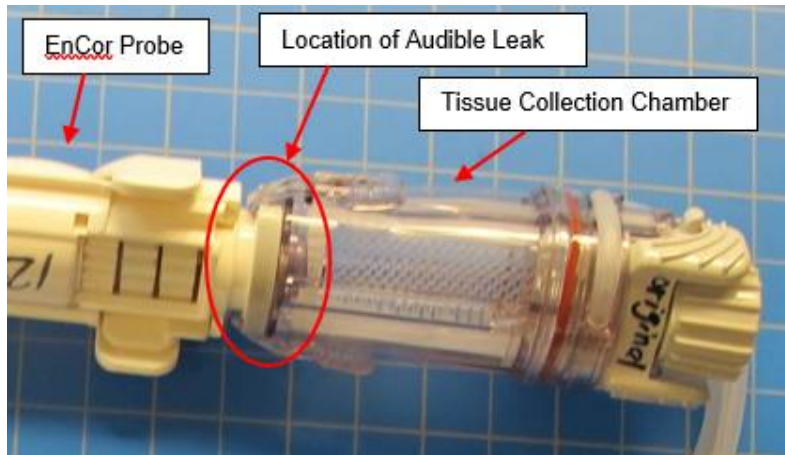
**Figure 1: EnCor® Breast Biopsy Probe**

The EnCor® Breast Biopsy Probe is used to acquire tissue for diagnostic sampling of breast abnormalities. Based on customer feedback, BD has identified that the product codes/ lot numbers listed in Table 1 on Page 3, may be at risk of experiencing a leak at the location referenced in the figure above, which could result in:

1. The sample chamber filling with blood with the potential to leak onto the driver and/or driver gears during the procedure and/or,
2. Minimal suction which has the potential to result in a minimal or no tissue sample obtained.

1. After calibrating the ENCOR® Breast Biopsy Probe, press and hold the VAC button on the ENCOR® Breast Biopsy Driver or the VAC button on the foot pedal. Inspect the probe and listen for any abnormal hissing sounds at the connection between the ENCOR® Breast Biopsy Probe and the Tissue Collection Chamber.

2. If any abnormal hissing sounds are heard, gently rotate the Tissue Collection Chamber a quarter turn in either direction until the hissing sound abates.

3. If the hissing sound remains, remove the Tissue Collection Chamber by depressing the wings on the chamber body and pull back on the Tissue Collection Chamber. Then reconnect the Tissue Collection Chamber by gently pushing it back on the ENCOR® Breast Biopsy Probe until the wings click back onto the probe body.

4. If the hissing sound is still present, replace the device and repeat the steps above. If the issue persists, please contact your local BD representative.
