**URGENT - Medical Device Recall
IntelliVue MX40**

Increased Battery Power Consumption and Absence of Low Battery Alerts

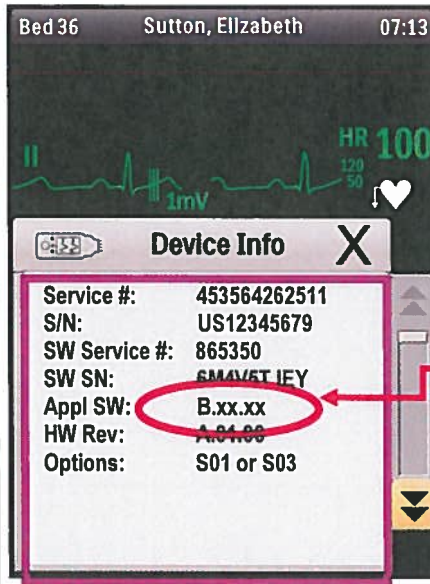
Device Info Screen

The first problem affects all MX40 Patient Worn Monitors with revision B software which may result in excessive battery power consumption. Specifically, the duration that the MX40 operates on a fully charged battery is approximately 25% shorter than is specified in the *MX40 Instructions for Use*.

Confirm Revision B software

Customers should maintain an adequate supply of fully charged batteries given the approximately 25% increased power consumption.

Philips Healthcare will release a software revision, which will correct both issues. Philips will contact you to arrange for software correction.

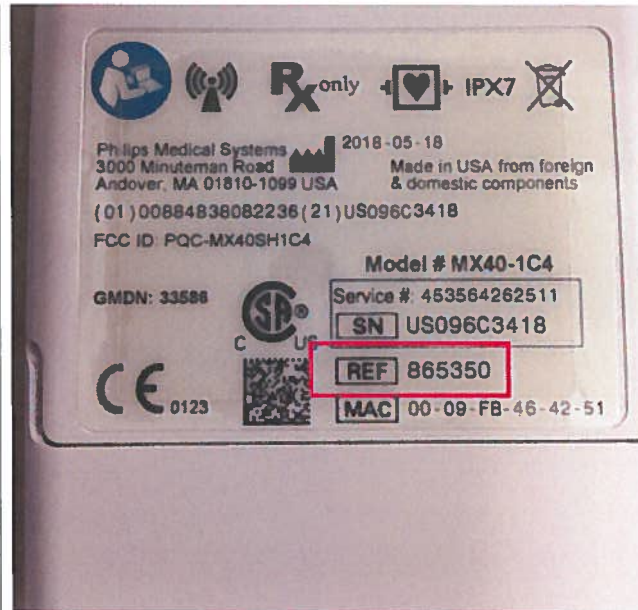
Problem 2 / Step 1

The second problem affects only a subset of MX40's with the pulse oximetry option and which use non-rechargeable AA batteries. In affected units, using SpO₂ automatic measurement mode may result in intermittent or missing low battery alerts. MX40 devices that use rechargeable batteries are not affected by this problem.

Confirm 865350 or 865351 part number ("REF")

Switch to continuous or manual SpO₂ measurements if your unit is using automatic measurement mode.
