Philips Ultrasound

FSN79500527

URGENT – Field Safety Notice

Philips S7-3t & S8-3t Transesophageal (TEE) Transducers Temperature Display Issue

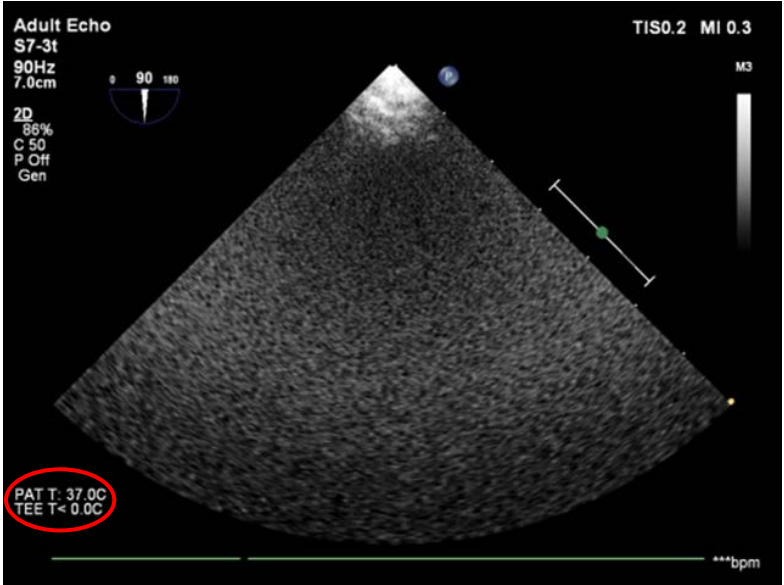
AFFECTED PRODUCTS	S7-3t & S8-3t Transesophageal (TEE) Transducers
PROBLEM DESCRIPTION	A small number of S7-3t and S8-3t TEE transducers were not properly programmed during manufacturing, as a result the system is unable to correctly measure the temperature on the distal tip of the transducer. EPIQ, Affiniti and iE33 systems will show the transducer temperature (TEE T) as <0.0C (<32.0F) on the display. HD11 and CX50 systems will show the transducer temperature (TEE T) as <37.0C (<98.5F) on the display. This issue will result in affected transducers not initiating auto-cool during use, when the transducer distal tip temperature exceeds 41.0°C (105.8°F).
HAZARD INVOLVED	Potential burn of esophageal tissue if the affected TEE transducer distal tip temperature exceeds 42.5°C (108.5°F), and auto-cool is not initiated.
HOW TO IDENTIFY AFFECTED PRODUCTS	<p>The affected S7-3t and S8-3t TEE transducers can be identified by connecting them to an EPIQ, Affiniti or iE33 system, and checking the transducer temperature (TEE T) that appears on the display when enabled. Affected transducers cannot be detected using HD11 or CX50 systems. See instructions below for each system.</p> <p><u>For EPIQ, Affiniti, & iE33 systems</u></p> <ul style="list-style-type: none"> • Connect the transducer to the system and ensure that it is secure and locked. • If the preset is not already selected by default, select it as follows: <ul style="list-style-type: none"> ○ S7-3t - Adult Echo, or ○ S8-3t - Pediatric. • Find the transducer temperature (TEE T) that appears in the lower left corner of the display. • If the transducer temperature on the display shows TEE T <37.0C (<98.5F), then the transducer was properly programmed, and no actions are required. • If the transducer temperature on the display shows TEE T <0.0C (<32.0F), then the transducer was not properly programmed (see image below), discontinue using the transducer and contact your local Philips representative. • If the transducer temperature (TEE T) does not appear in the lower left corner of the display, follow the instructions below to enable it: <p>EPIQ & Affiniti</p> <ul style="list-style-type: none"> • Swipe to the second touch screen • Touch Temp Display to display the temperature display <p>iE33</p> <ul style="list-style-type: none"> • Display the Preset/Transducer touch screen by touching Preset/Transducer • Touch Temp Display to display the temperature display

<p>For HD11 & CX50 Systems</p> <ul style="list-style-type: none"> Discontinue using the transducer immediately and contact your local Philips representative for support.
<p>ACTION TO BE TAKEN BY CUSTOMER / USER</p>	<p>If you have an EPIQ, Affiniti or iE33 system, verify that all your S7-3t and S8-3t TEE transducers are programmed properly by connecting them to the system, checking the transducer temperature (TEE T) on the display, and following the instructions provided on this letter.</p> <p>If you determine that your transducer is not properly programmed, discontinue using the transducer immediately and contact your local Philips representative to schedule an appointment with a field service engineer.</p> <p>If you have an HD11 or CX50 system discontinue using the S7-3t and S8-3t transducer immediately and contact your local Philips representative for support.</p> <p>Please complete the included reply form on the last page and return to Philips as soon as possible via email to ultrasound.corrections@philips.com, or fax to 1-833-512-7756.</p>

<p>ACTIONS PLANNED BY PHILIPS</p>	<p>Philips will resolve the issue by replacing the affected transducers at no cost.</p>
<p>FURTHER INFORMATION AND SUPPORT</p>	<p>If you need any further information or support concerning this issue, please contact your local Philips representative <i><Philips representative contact details to be completed by the Market></i>.</p>
