URGENT – Field Safety Notice **Philips V60/V60 Plus Ventilators**

Information regarding High Flow Therapy Option

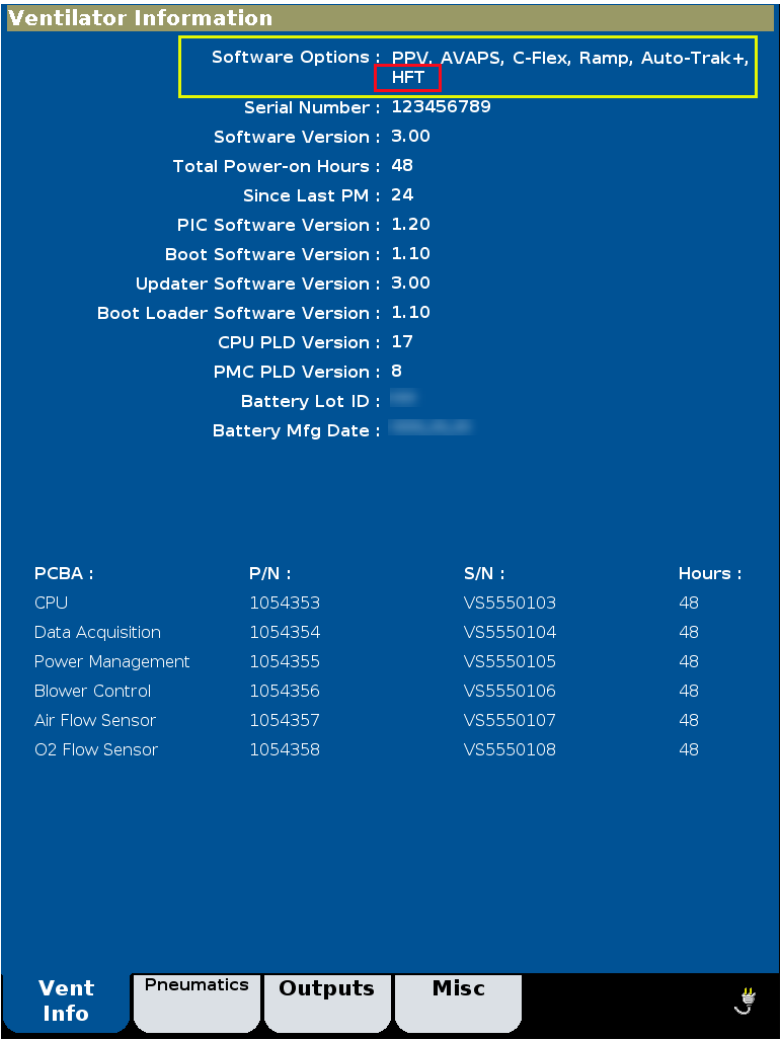
Figure 5: Vent Info tab. Refer to the Software Options list at top of the Vent Info Screen

5. From the **Service** screen (Figure 5), review the **Vent Info** tab information.
6. In the **Software Options:** section of the **Vent Info** screen, look for the option HFT within the list. If HFT option is in the listed, the ventilator is affected.
