**الموضوع:** إشعار بمتابعة جهاز طبي

Vascular Grafts, Biplex vascular grafts and Biplex Biovalsalva conduits

## URGENT FIELD SAFETY NOTICE

**Name of product affected:** Biplax vascular grafts and Biplax Biovalsalva Conduits (stentless and stented)

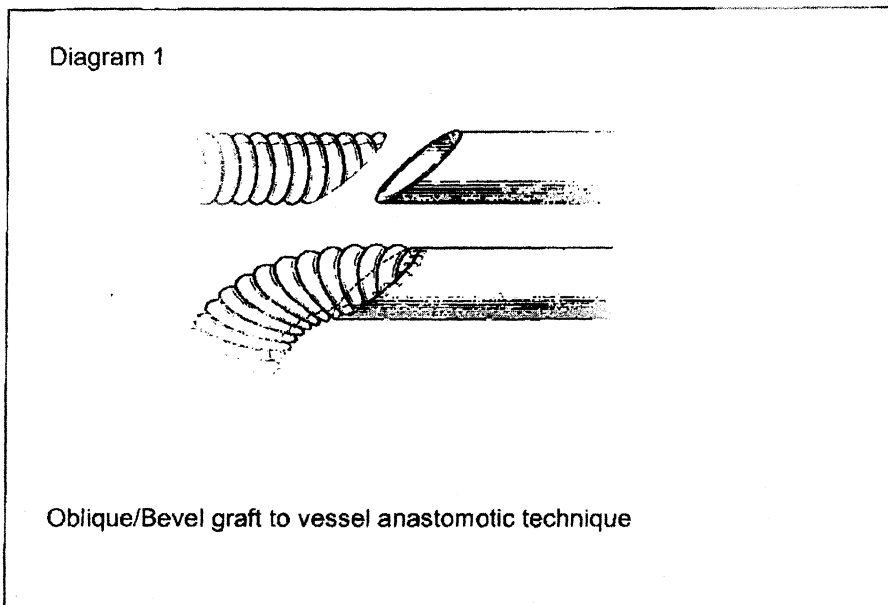
1. It is essential that the sutures are tightened each time they are passed through the material.
2. In order to achieve a smooth suture line and good haemostasis, it is important that the graft diameter selected must not be oversized relative to the distal anastomotic site.
3. Care should be taken not to apply excessive tension at the distal anastomosis by ensuring the graft is cut to the correct length.
4. The use of haemostatic agents/ accelerants and/or felt/ pledgets may reduce the incidence of suture line bleeding and resternotomy.
5. The use of an oblique/ bevel graft to vessel anastomosis is recommended. This technique will minimise any blood leakage arising from the oversizing of the graft relative to the native vessel (see Diagram 1)
