# LIFE 18™ apheresis unit Field safety notice

Surveillance gap in the blood leak detection of the LIFE 18™ apheresis system

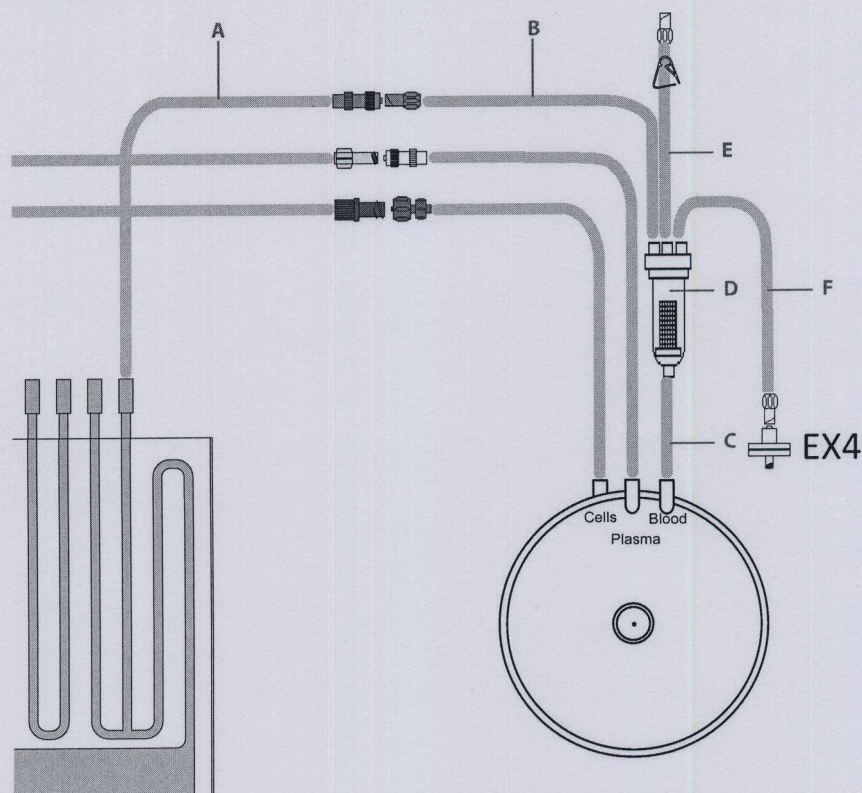
Figure: connection of Disk Separator with Theraline or TPE Line pump cassette.

During a treatment blood is withdrawn from the venous access of the patient and delivered to the Disk Separator via the tubing lines (depicted as A to C in the figure above) and the Disk Separator drip chamber (depicted as D). The pressure in the drip chamber is monitored by external sensor EX4. This flow path is checked for tightness during the set-up procedure.

If a leak develops in this flow path of the blood during the treatment, usually the pressure will drop and the external pressure sensor EX4 will raise an alarm if the pressure is not fluctuating (or alternating) within a certain range.

Tests in our laboratory have shown the possibility that under certain circumstances the LIFE 18 apheresis unit will not interrupt the treatment and stop all pumps if a blood leak occurs in the tubing of the Disk Separator (anywhere between A and F in the figure above).

If such a phenomenon occurs during treatment and would remain undetected by the user, the patient might lose significant blood volumes.

**Please make sure that the patient connected with the LIFE 18 apheresis unit never remains unattended during the treatment. Please check for tubing set integrity regularly during the treatment.**

Our company is working hard to solve this potential problem by a modified software with an improved surveillance of the blood pumps. The development, verification, validation and release of the revised software however will probably require several weeks. In addition, the thorough installation of the revised software on all LIFE 18 apheresis units by our qualified service engineers will also require significant time.

The above indicated initial action presents an intermediate preventive action, before the revised software will be able to correct the gap in the blood leak detection of the LIFE 18 apheresis unit.
