**To the customers and users of the
emergency breathing devices
Oxylog 3000 and Oxylog 3000 plus**

December 2016

Important safety information!!!

**Oxylog 3000, Oxylog 3000 plus
Failure of ventilation function with "Control knob faulty" error message**

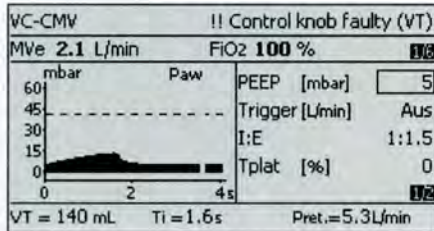
Our investigations indicate that the error condition is caused by an oxide layer in the potentiometer. These oxide layers may accumulate over a longer period of time if various factor collude i.e. if the knobs are moved rarely or never. A verified remedy is repeated twisting of the knobs that removes the oxide layer. This recommendation was described in the previous Safety Notice.

Whenever a "Control knob faulty" condition will occur with a device being equipped **with the new software the device will continue to ventilate with the last valid settings**, display for example the values for tidal volume in case of a defective potentiometer for VT and post the corresponding alarm (see Picture below)

However, this particular error condition was still reported from the field after the Safety Notice. The remedy of twisting the knob is still considered effective. Nonetheless, to reduce the impact of this special error condition Dräger has developed a new software that reduces the impact of the error condition.

Software version 1.06 will now be introduced for Oxylog 3000plus, version 1.23 for Oxylog 3000, respectively.

As reflected in the amended IfU you are advised to check patient's condition and the ventilation.
