## Urgent Field Safety Notice

### Single Chamber Temporary External Pacemaker 53401

June 2018

Medtronic reference: FA824

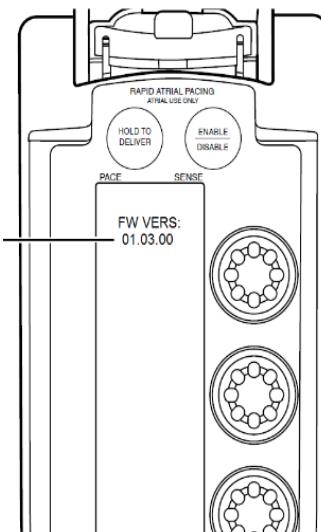
**FIGURE 1- updated firmware displayed in this image**

1. Verify whether 53401 EPGs in your possession are affected
2. If your EPG is affected, complete the following:
  - o Determine if the EPG firmware has been updated.
    - Power unit on and view firmware version (Figure 1 below).
    - If firmware version is 01.03.00 or greater, EPG firmware has been updated with correction for this issue. No other action is recommended.
    - If firmware version is 01.02.00, EPG firmware has not been updated. You may arrange to have your Medtronic Service Center update the EPG firmware at no charge.

During power up process, Firmware Version will be displayed for 2 seconds

Recently, Medtronic received approval for a firmware correction that prevents occurrence of this issue. Medtronic recommends customers send affected devices to Medtronic Service to update the firmware to prevent this issue.
