## Information Urgente de sécurité

### Erreur de validation des données du système Intellis™ Mise à jour logicielle modèle A710 vers la version 1.3.130

Décembre 2020

Référence Medtronic : FA949

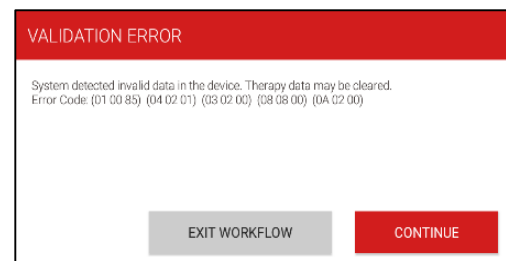
Figure 1 : message indiquant l'erreur de validation

Medtronic a reçu quatorze (14) rapports entre janvier 2020 et le 24 novembre 2020 indiquant que des utilisateurs avaient constaté cette erreur de validation (Figure 1) suivie d'une erreur système (**Erreur ! Source du renvoi introuvable.**) sur l'application logicielle Intellis A710 version 1.3.80 du programmeur médecin CT900 indiquant que la mise à jour de programmation du simulateur n'avait pas pu être menée à terme. Après investigation, il a été établi qu'il y avait une corruption dans un emplacement spécifique de la mémoire du simulateur et que l'application logicielle Intellis A710 version 1.3.80 n'effaçait pas cette corruption comme elle aurait dû le faire, ayant pour conséquence une erreur système. Cette erreur système n'est pas courante et la fréquence rapportée est inférieure à 1 sur 10 000.

Ce problème apparaît et est reconnu dans l'environnement clinique lorsque le patient est suivi par un professionnel de santé. Si vous rencontrez « VALIDATION ERROR » (L'erreur de validation, comme indiquée ci-contre) avec le code d'erreur (01 00 85) (04 02 01) (03 02 00) (08 08 00) (0A 02 00) **avant** d'installer la dernière version de l'application logicielle Intellis A710, v1.3.130, veuillez sélectionner l'option « **CONTINUE** » (Continuer). Si « **EXIT WORKFLOW** » (Quitter flux de travail) est sélectionnée, veuillez rétablir la communication et sélectionner « **CONTINUE** » (Continuer) en présence de « VALIDATION ERROR » (L'erreur de validation) (figure 1).

Veillez télécharger la dernière mise à jour de l'application logicielle Intellis A710, version 1.3.130, sur le programmeur médecin CT900 en respectant les instructions jointes.

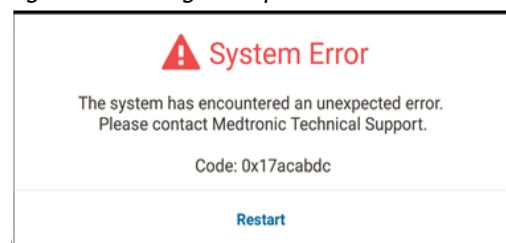
Après avoir sélectionné l'option « **CONTINUE** » (Continuer), si cette « **System Error** » (Erreur système) (Figure 2) s'affiche, veuillez

contacter votre représentant Medtronic pour obtenir de l'aide pour le téléchargement de la toute dernière application logicielle Intellis A710 v1.3.130. Après avoir téléchargé la toute dernière application logicielle Intellis v1.3.130, veuillez rétablir la communication et sélectionner « **CONTINUE** » (Continuer) pour corriger ce problème.
