## Urgent—Medical Device Field Safety Notice (FSN) Voluntary Withdrawal of Mi1000 PIN Drills (REF 07756 and REF 07758)

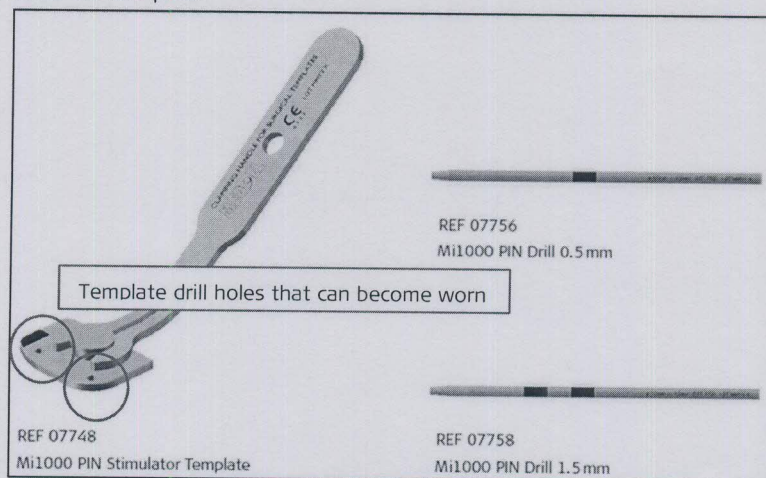
The Mi1000 PIN Drill Guide (REF 07613) is an optional, reusable surgical tool that can be used by ENT surgeons during Mi1000 CONCERTO PIN surgeries. The Mi1000 PIN Drill Guide (pictured below) consists of Mi1000 PIN Stimulator Template (REF 07748) consisting of a titanium base and clamping handle (left) and two drills (right) for 0.5mm (REF 07756) or 1.5mm (REF 07758) drilling depth. The purpose of this tool is to determine the correct distance between drill holes for the pins.

If the holes of the Mi1000 PIN Stimulator Template are damaged or excessively worn after repeated use, this can lead to enlarged drill holes. If this occurs and the included stainless steel Mi1000 PIN Drills are used with a worn template, the integrity of the stopper function of MED-EL supplied drills might be compromised and allow the drills to penetrate beyond the indicated depth. This specific combination of factors can create a potential hazard whereby the stepped drill can penetrate more deeply into the bone than intended, and possibly cause damage to anatomical structures during the use of the Mi1000 PIN Drill Guide. The current Instructions for Use (IFU) of Mi1000 PIN Drill Guide (AW7616) contain the following precautions and warnings:

Because repeated use can enlarge the Template drill holes and the required visual inspection of these parts may prove to be challenging due to the small size of the holes, MED-EL, as a precautionary measure, has determined that the Mi1000 PIN drills must no longer be used to prevent the possibility of such an occurrence. The Mi1000 PIN Stimulator Template and handle (left, above) can still be used to mark the distance and location of the holes to be
