Field Corrective Action

Inspiration[®] Ventilator System 12 Oct 2016 Powerboard Reset Switch Removal

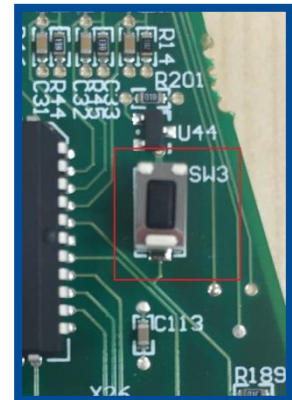
eVent Medical has identified a potential problem with the power reset switch (SW3) located on the Inspiration's Powerboard (PN: F720511 or EVM300147).

If this switch malfunctions, the ventilator may shut down with no alarm.

eVent Medical is requesting that all users of the Inspiration Ventilator remove the power reset switch from the Powerboard.

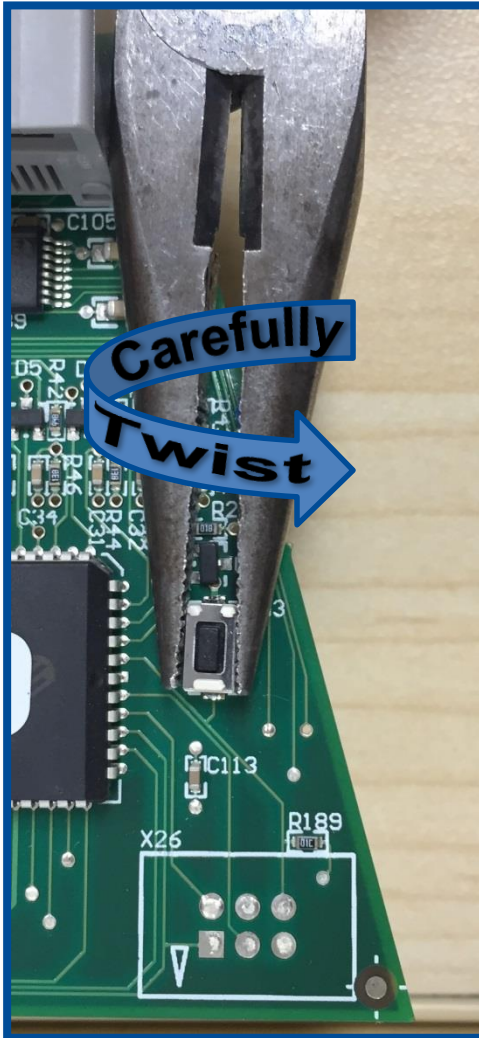
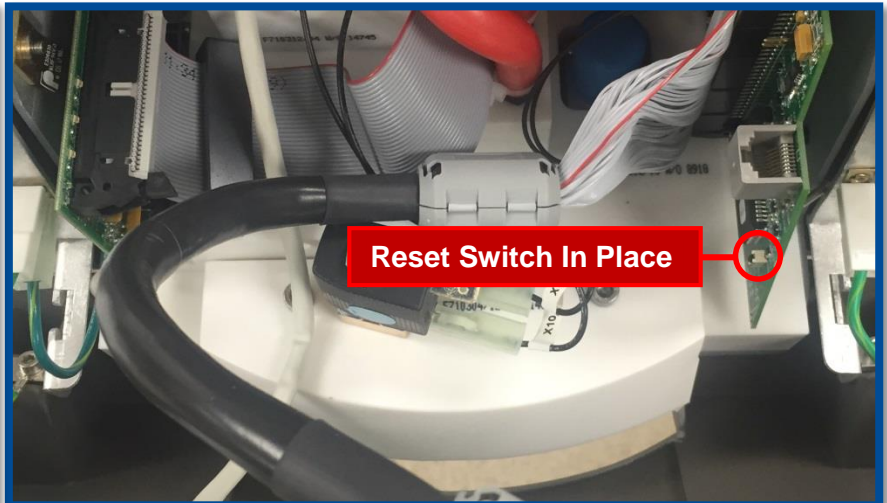
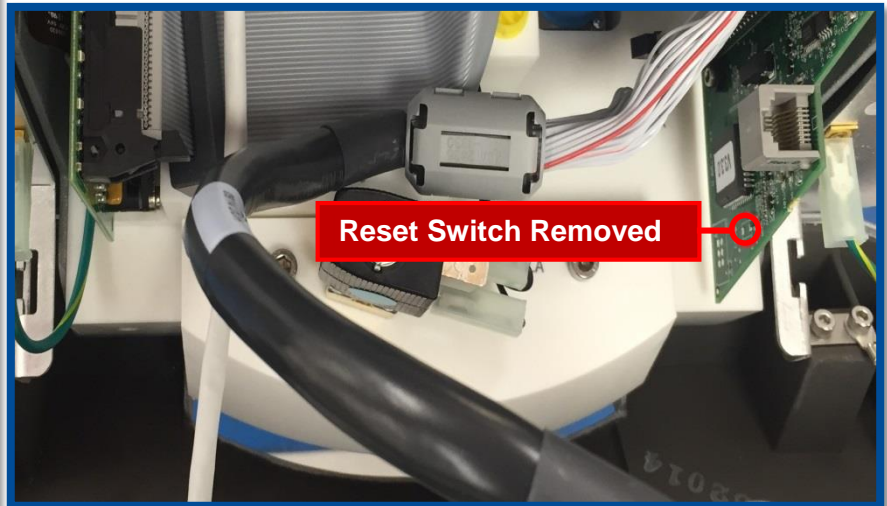
A. To remove the reset switch from an Inspiration Ventilator follow these steps.

1. Disconnect AC power from the ventilator.
2. Disconnect the internal batteries.
3. Remove the Front Enclosure.
4. With a pair of small, needle-nosed pliers, carefully remove the power reset switch from the Powerboard.

B. Once the reset switch has been removed follow these steps.

5. Re-install the Front Enclosure.
6. Reconnect the internal batteries
7. Reconnect AC Power.
8. Turn the ventilator on. Verify that the ventilator passes the Power On Self Tests and runs normally.
