[Reference: QIL-150P-02]

[URGENT: FIELD SAFETY NOTICE / FIELD SAFETY CORRECTIVE ACTION]

Regarding: Cystoscopy Bridges and Working Inserts - detaching fragments of adhesive

Model Number	Model Description	Lot Number(s)
A20975A	Working insert, with ramp, one way	[to be populated]
A20976A	Bridge, one way	[to be populated]
A20977A	Bridge, two way	[to be populated]

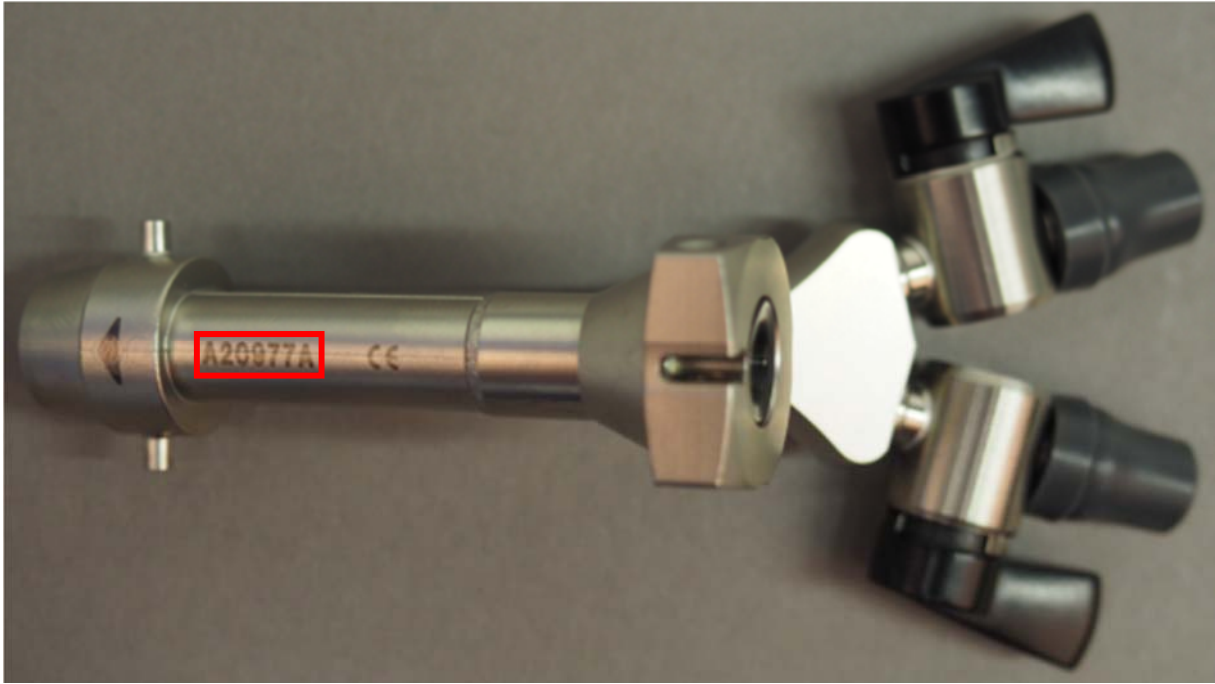
Picture 1: model number on the cystoscopy bridge

1. Inspect your inventory for the referenced devices and identify any of the specified model and lot numbers identified above. The model and lot number can be found on the device as illustrated in the following pictures.

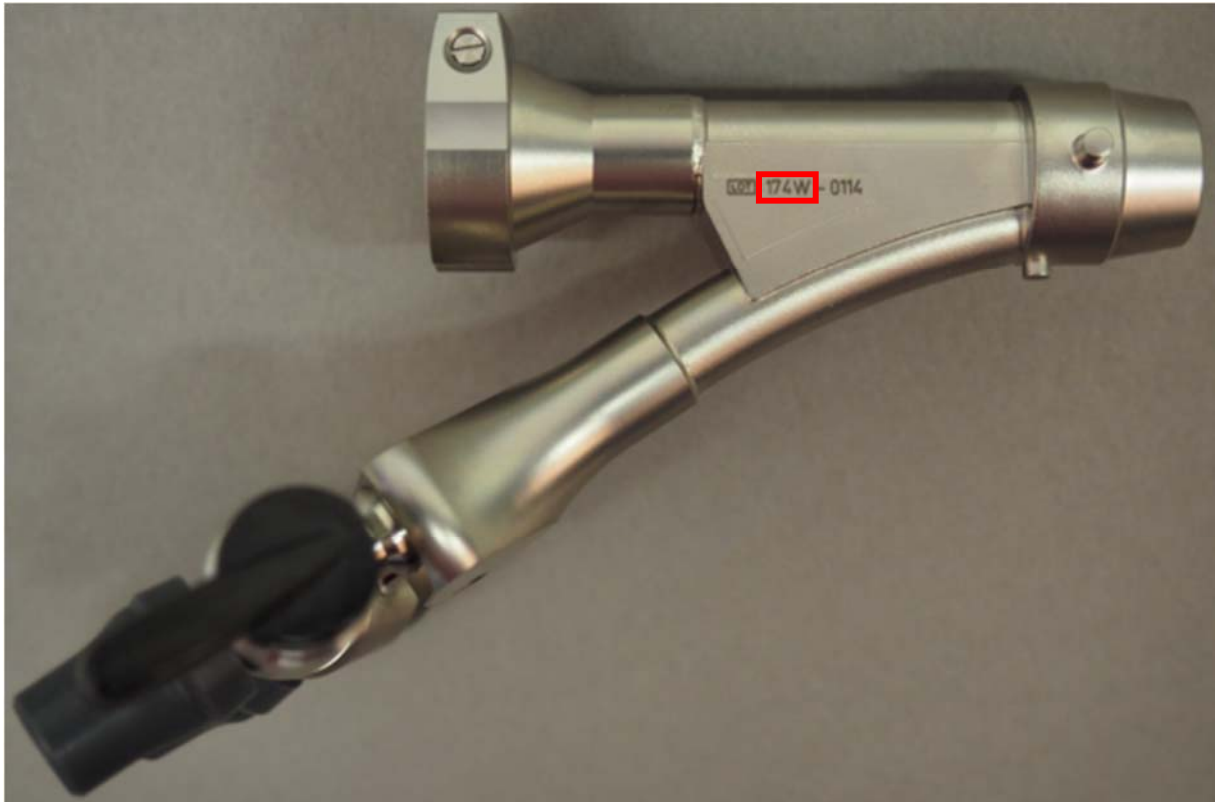
Picture 2: lot (LOT) number on the cystoscopy bridge

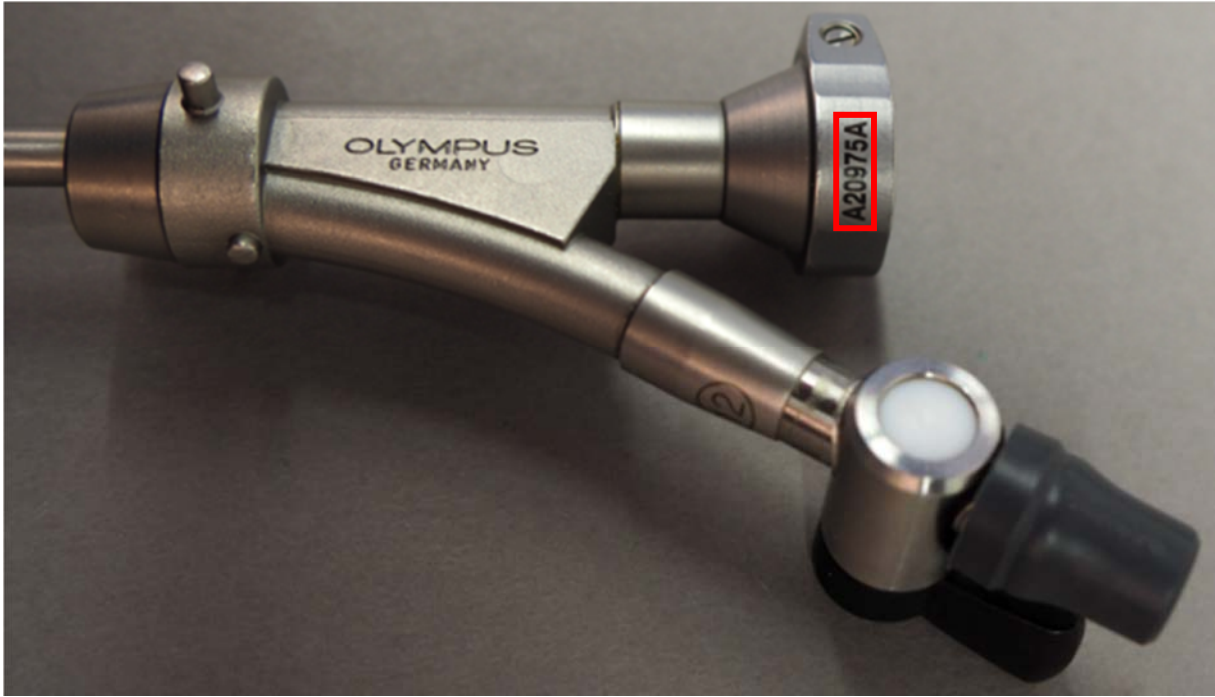
Picture 3: model number on the working insert

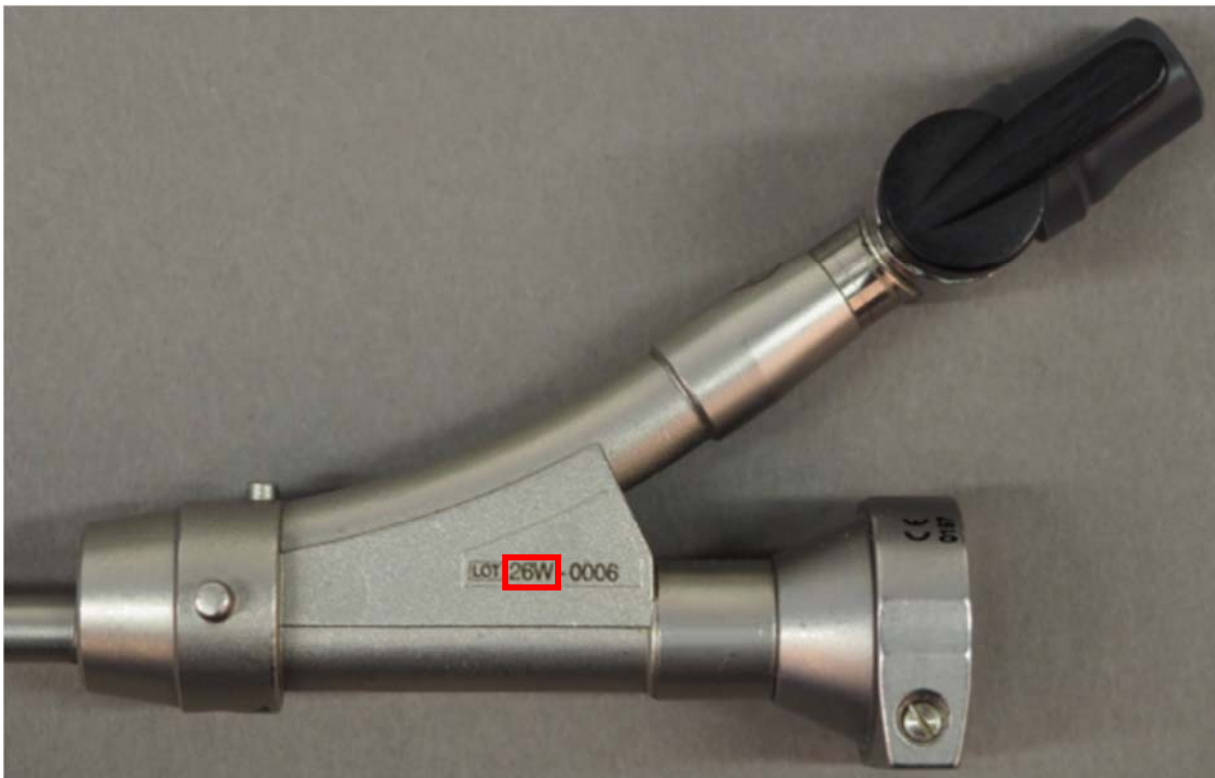
Picture 4: lot (LOT) number on the working insert
