URGENT: FIELD SAFETY NOTICE – PI-21-3959

BARD® MARQUEE® Disposable Core Biopsy Instruments and Kits

Type of Action: Product Removal

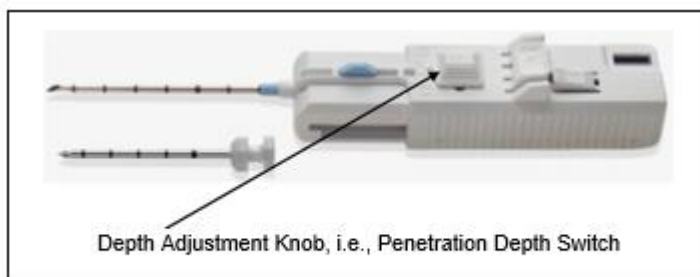
Figure 1; BARD® MARQUEE® Disposable Core Biopsy Instrument

Through customer feedback, BD has discovered the specific lots of BARD® MARQUEE® Disposable Core Biopsy Instruments and Kits listed in Table 1 above have a potential fault in the Penetration Depth Switch (refer to Figure 1). The events that BD have received reported that the Penetration Depth Switch, depicted in the image below; used to select the desired penetration depth of tissue biopsies, detached from the device during use.

A Penetration Depth Switch detachment may result in (1) prolongation of the biopsy procedure as the user obtains a replacement device, (2) undershooting the lesion unexpectedly, compromising the sample quality and potentially leading to a misdiagnosis or (3) if the penetration is overshoot, the device may pierce adjacent tissue and/or organs causing injury. Medical or surgical intervention may be required. No specific patient follow-up activities are recommended for affected devices already used to take a biopsy. However, any clinical considerations, including further diagnostic testing to ensure adequate sampling has been obtained and/or if any inadvertent injury may have occurred should be at the discretion of the medical doctor.

1. Inspect your inventory, locate and quarantine any units of the impacted devices listed in Table 1.
2. If you have further distributed the product, please identify those facilities, notify them at once of this product removal and have them destroy the affected product.
3. Destroy any unused units of the affected product and complete the customer response form on page 3 indicating:
 - o the quantities destroyed **OR**
 - o that your organisation does not have any impacted units left in inventory
4. Return the completed Customer Response Form to Ahmed.Shebah@bd.com **as soon as possible or no later than March 12th, 2021.**
