### URGENT FIELD SAFETY NOTICE

Product Name: **Alaris™ GS, GH, CC, TIVA, PK, Enteral Syringe Pump**

FSCA Identifier: **RA-2017-02-02**

## Appendix 4 – Plunger Backplate Spring Replacement

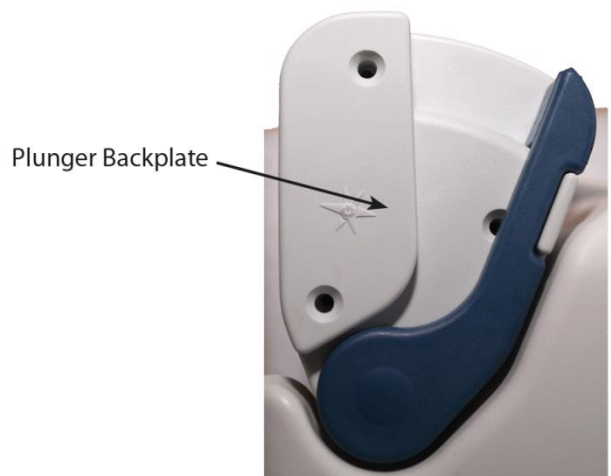
3. Remove three screws holding plunger backplate.

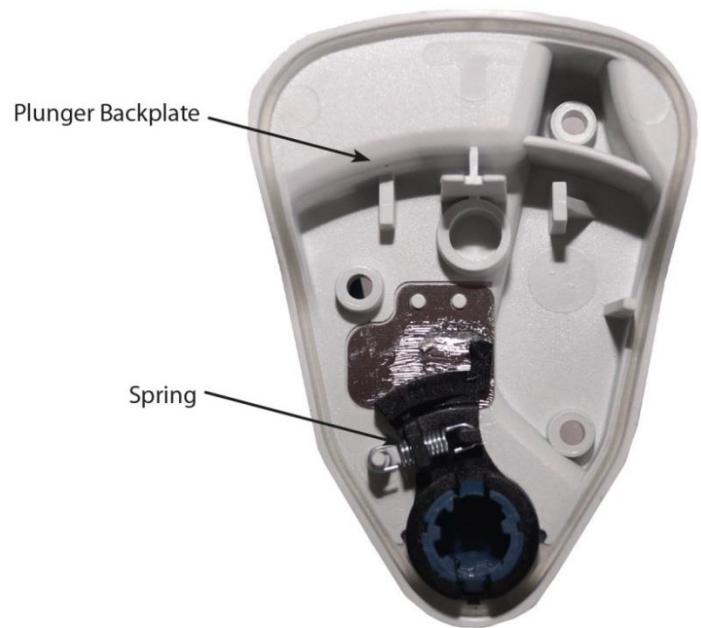
4. Remove the spring from the plunger backplate.
5. Fit a new spring to the plunger backplate.
6. Refit the plunger backplate.
7. Fit the three screws into the plunger backplate.
