**Urgent Field Safety Notice**  
**WiSE CRT Electrode-Catheter Model 1000**

**Urgent Field Safety Notice (FSN)**  
**WiSE CRT Electrode-Catheter Model 1000**  
**Receiver Electrode Detachment Issue**

**Appendix B: Amended Electrode Delivery System Instructions for Use**

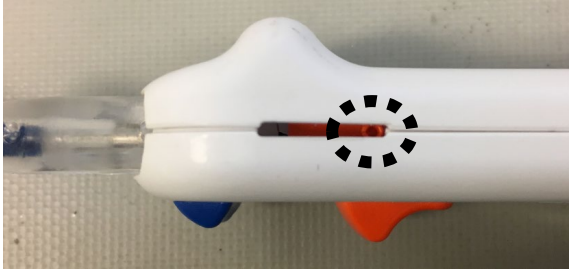
3.	2. By when should the action be completed?	Ahead of next scheduled device implant	
3.	<b>3. Is customer Reply Required?</b>		Yes (see Appendix C)
3.	<p><b>Action Being Taken by the Manufacturer</b></p> <p><input checked="" type="checkbox"/> IFU or labelling change  <input checked="" type="checkbox"/> Other: Additional Training</p> <p>The following actions are currently in place to address the device problem:</p> <ul style="list-style-type: none"> <li>• An EBR technical field representative will provide training to all implanters ahead of their next implant, and</li> <li>• An EBR technical field representative will be present at every procedure to provide support to the implanter, and</li> <li>• There are additional real-time indicators during the procedure to aid in the assessment of electrode detachment such as EGM signal and the position of the circle of the orange indicator on the side of the handle (described below). This orange indicator may also be referred to as “boss”. This is the same sliding part that contains the detach indicator. <ul style="list-style-type: none"> <li>○ If the user is uncertain whether or not the electrode was successfully detached, the EBR technical field representative will advise the user to look on the slot on the side of the handle to confirm electrode detachment. Electrode detachment is confirmed when the circle of the orange indicator is positioned on the proximal side of the handle (see below figure, where indicator is shown in the dashed-circle).</li> <li>○ In the scenario where it is unknown if the Electrode has completely detached, a manual completion of the electrode detachment procedure step can be performed, as detailed in Appendix B.</li> </ul> </li> </ul> <div style="text-align: center;">

</div> <p>Short term implementation of the above actions is to provide the required details in Appendix B of this Field Safety Notice so that the user is aware of and understands the potential Model 1000 detachment problems and the appropriate steps to evaluate and resolve the issues.</p> <p>The long term implementation is to distribute the amended Instructions for Use document to users once the Notified Body has completed their review of the amended information.</p>

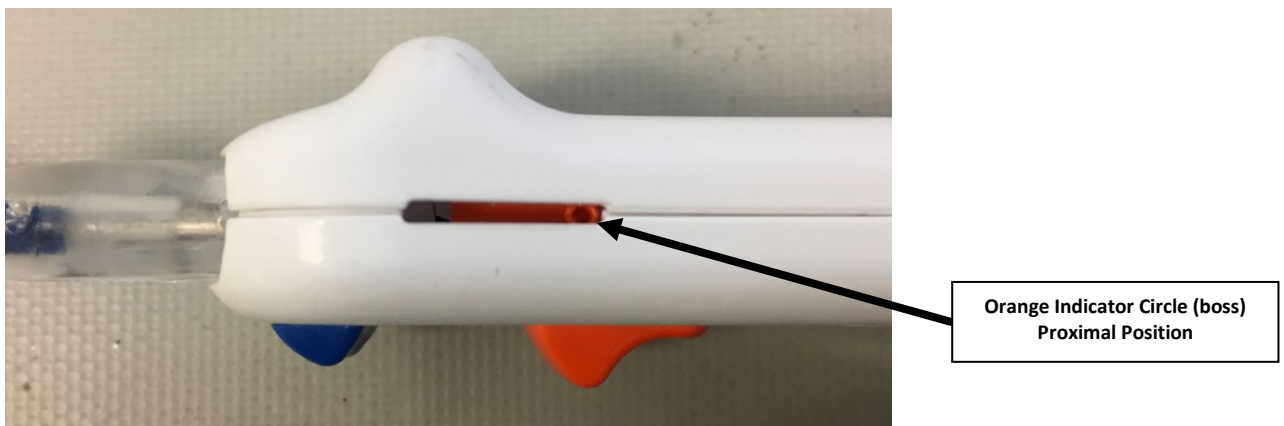
*Figure 1: Electrode Detached - Orange Indicator Circle (boss) at Proximal Side of Handle*

- **Follow the steps in the IFU to remove the Electrode Delivery System; or**
  - **Complete the following sequence of steps to visually assess detachment, and if indicated, perform a manual Electrode detachment.**
1. Visual Assessment: On the catheter handle, examine the side port and determine the position of the orange circle (also referred to as “boss”). If it is fully proximal, as shown below in Figure 1, indicating that the Electrode is detached, proceed to release the electrode from the sheath per the IFU. If the “boss” is not proximal (as shown in Figure 2), indicating that the Electrode is not detached, proceed to step 2 below, Manual Detach

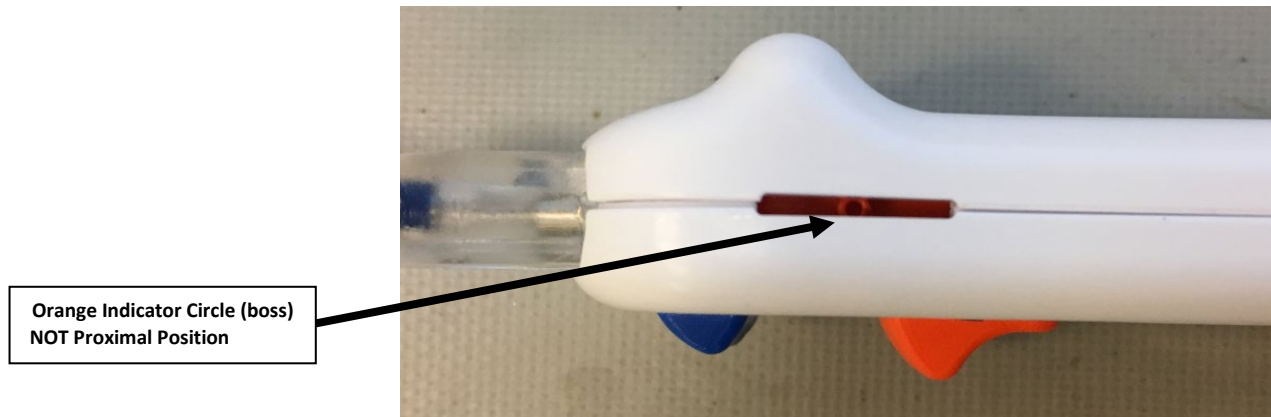
*Figure 2: Electrode not Detached - Orange Indicator Circle (boss) NOT at Proximal Side of Handle*

2. Manual Detach: While maintaining the position of the Electrode and Delivery Sheath, as shown below in **Figure 3**, push and hold the orange detach button forward and at the same time insert a tool like a forceps or similar into the side port to engage the “boss” (orange circle), and slide the “boss” proximal. The distal tip of the tool should be approximately 1mm diameter and 7mm long to engage the boss feature. Afterwards, release detach button and verify the orange circle (boss) remains fully proximal. If proximal (as shown above in Figure 1), proceed to release the electrode from the sheath per the IFU. If the Orange Indicator Boss is not proximal (as shown in Figure 2, follow the steps in the IFU to remove the Electrode Delivery System.

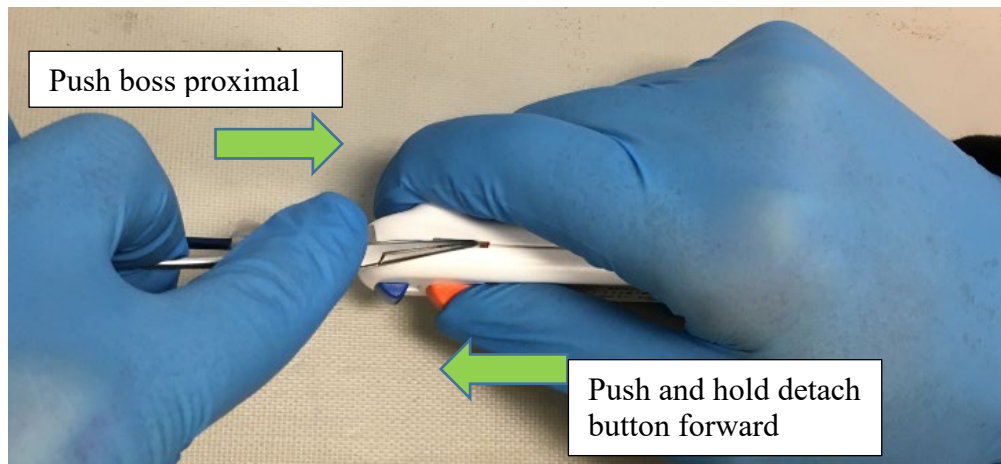
*Figure 3: Electrode Manual Release*
