Reference: 92201802-FA

Urgent Field Safety Notice - Important Medical Device Information
Capio™ Suture Capturing Devices (SLIM, Standard, Open Access, RP)
Uphold LITE with Capio™ SLIM Vaginal Support System
Pinnacle™ Anterior Pelvic Floor Repair Kit
Pinnacle LITE Posterior with Capio SLIM Pelvic Floor Repair Kit

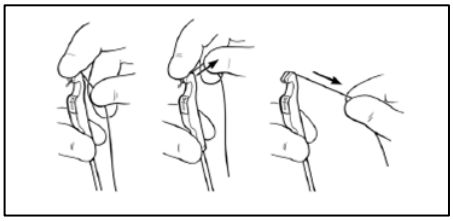
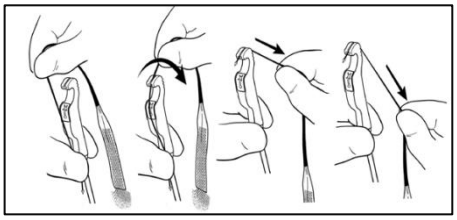
Prior To Deployment	
Capio Family of Products	**Pelvic Floor Kits**

Note: When loading a dart into the device, verify that the dart is properly positioned in the carrier. The tip of the dart should not protrude from the Capio Device tip.	**Note:** When loading a dart of the leg assembly into the device, verify that the dart is properly positioned in the carrier. The tip of the dart should not protrude from the Capio Device tip.
