Urgent Customer Communication

Notice of potential leakage during procedure preparation due to cracked luer hub

Cordis® S.M.A.R.T.® Flex Vascular Stent System 85 lots across 48 catalog numbers- See listing in Table 1

November 15, 2017

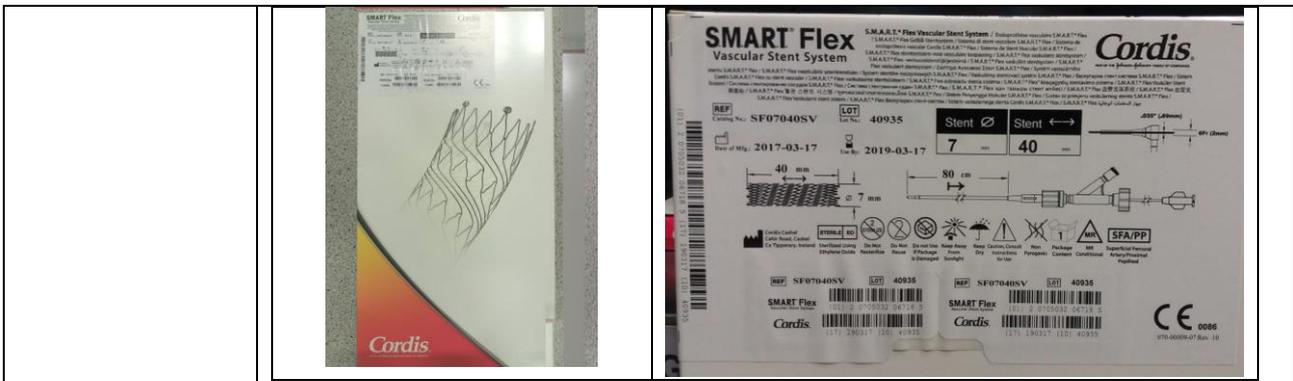
What is the summary of the issue?
 Due to a manufacturing error, some luer hubs in the affected lots may have cracks. Most of the cracks observed in the investigation were minimal, resulting in slight leakage of saline, but the degree of cracking varies.

Inspection details:	<p>As stated in the Instructions for use, users are warned that the device should not be used if the outer sheath cannot be flushed. Inspect for leakage during preparation of the device. Leakage may be more likely in the affected product due to cracks in the luer. At time of actual flushing, if there is no leakage observed, the product may be safely used.</p> <p>For reference, cracks, when present, are visible in the region indicated in the photo below.</p>

- 5) **During procedure preparation, check** for cracks/leaks. If the user detects a crack prior to flushing, or a leak during flushing, select a replacement device. (See inspection section below.) Report the incident through the standard complaint process.
