Important Medical Device Information

Cardiac Rhythm Management

Root Cause Investigation

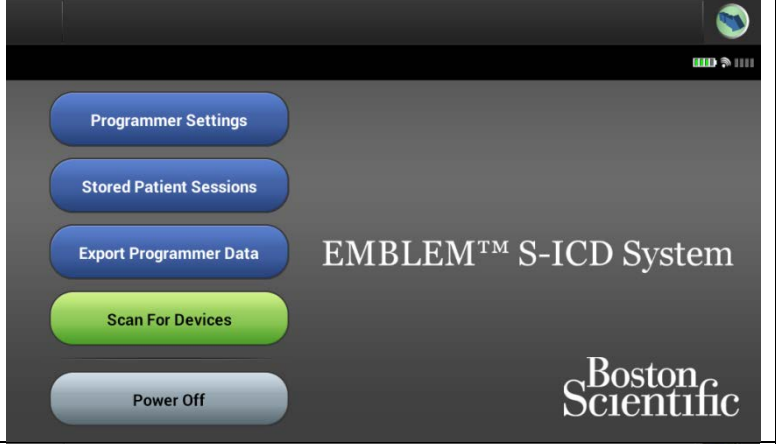
To identify the version of software on a Model 3200 S-ICD Programmer

<p>1. Select Programmer Settings</p>

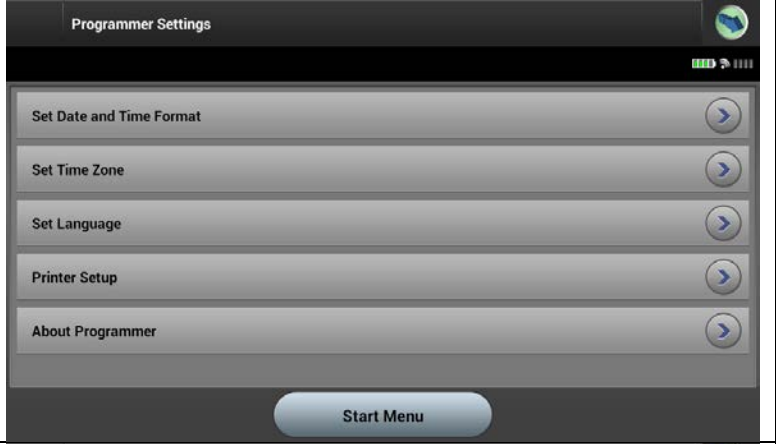
<p>2. Select About Programmer</p>

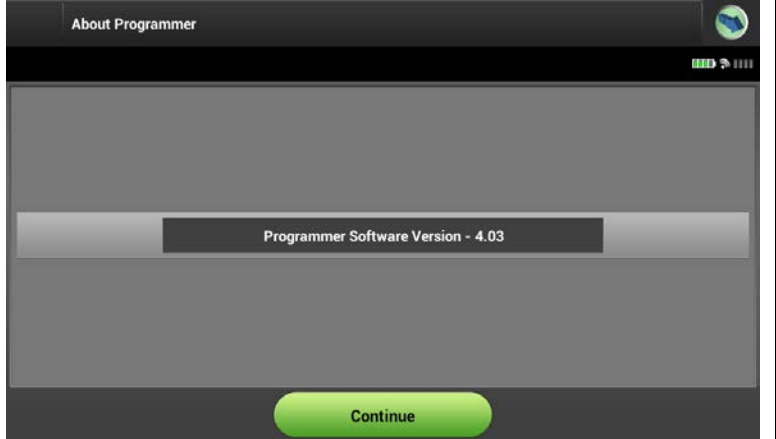
<p>3. Software that is version 4.03 or higher addresses this behavior for EMBLEM S-ICDs</p>

The programmer software version used for each S-ICD in clinic follow-up is documented on the top of the Summary Report.
