URGENT MEDICAL DEVICE CORRECTION

GEHC Ref# 32047

RE: Infant Warmer System (IWS) Hot “Heater Head” Screw could Fall onto the Bed

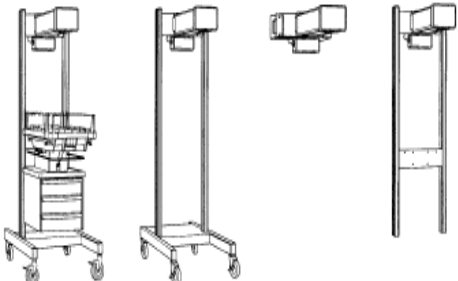
Affected model numbers: Model 2001 IWS (International), 3000 IWS, 3050 IWS, 3100 IWS, 3150 IWS, 3300 IWS, 3500 IWS, 4000 IWS, 4300 IWS, 4400 IWS, 5000 IWS.

Affected Products	Not Affected Products
