## Urgent Field Safety Notice

### Medtronic Model 37751 Recharger included in Model 37651 Charging System

October 2016

Medtronic reference: FA735

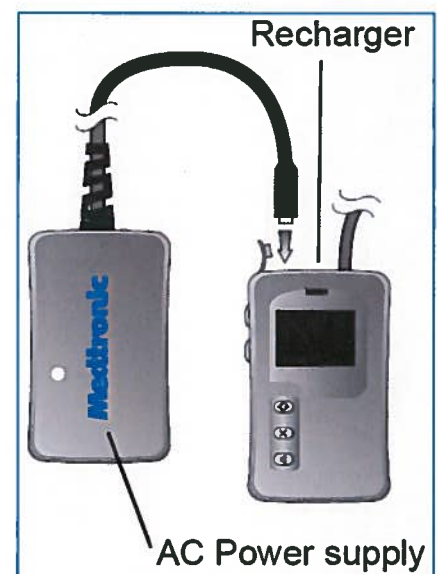
1. In order to prevent this unresponsive error state, the Recharger should be plugged into the AC power supply (by aligning white triangles) prior to begin a recharging session of the neurostimulator and the Recharger should remain connected to the AC power supply until the recharging session is complete (see Figure 1). Note: The AC power supply does not need to be plugged into a power outlet if the Recharger is charged.
2. If the Recharger is not connected to the AC power supply during a recharging session of the neurostimulator, the unresponsive error state may occur. In this situation, Medtronic requests that you assist patients with a reset of their Recharger by following the reset instructions enclosed. Note: This issue can recur after reset if the recharging instructions are not followed.

- To ensure this issue does not occur, Medtronic recommends all affected patients follow the recharge practice explained above. Keeping the Recharger plugged into the AC power supply during recharging will prevent this error state from occurring.
- If you are contacted by a patient with a Recharger in an unresponsive error state, you can assist the patient with a reset of their Recharger by following the reset instructions enclosed.
- Medtronic is working on a permanent solution for this issue. Until a permanent solution is in place, Medtronic recommends you discuss this issue and the issue mitigation with any new patient implanted with a rechargeable neurostimulator and provide them with a copy of the patient notification.
